## Technical Bulletin

# Hydraulic Power Brake (HPB) Master Cylinder Reservoir Cap Inspection and Replacement Guidelines

Navistar Truck and Bus with Full Power  
Brake (FPB) System

TP-1376  
 Revised 01-17  
 (16579)

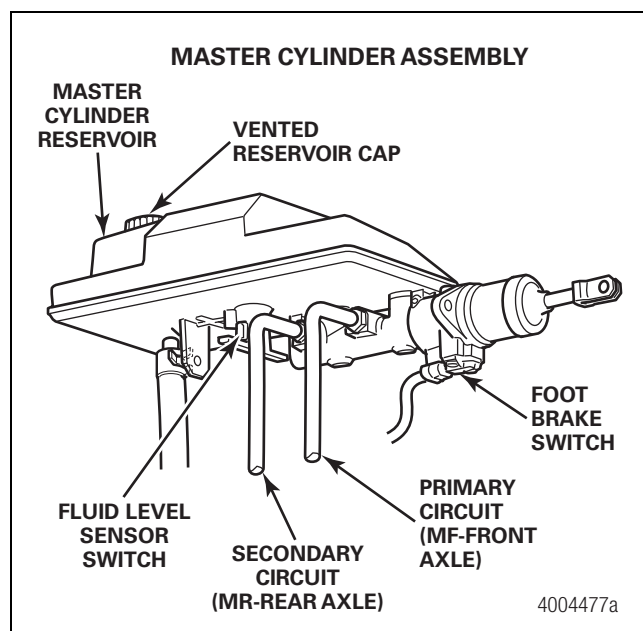
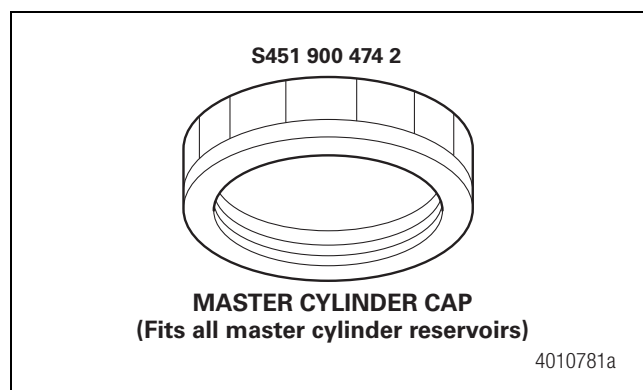
The full power brake system uses a master cylinder reservoir with additional volume to feed brake fluid to the hydraulic compact unit (pump system). To protect the fluid and to prevent pressurizing the reservoir, a venting cap is installed at the reservoir inlet. This cap prevents water and dust from entering the system. Figure 1 and Figure 2.

Much like the air inlet filter for an internal combustion engine, the filter mesh in this cap can become clogged with particles over time.

Meritor WABCO recommends you inspect and replace this cap as needed as part of an annual vehicle inspection for preventive maintenance.

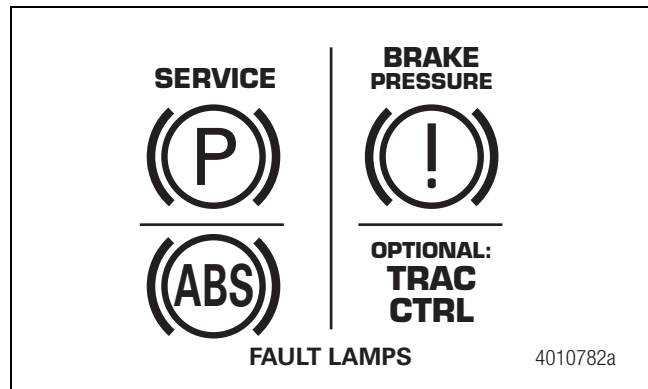
Figure 3

If the filter has become clogged, then a vacuum can build inside this reservoir. The build-up of vacuum affects the HPB pump system and its ability to charge the accumulators. Due to the starvation of fluid to the pump system, an accumulator charging fault may occur. For example:

- SID 57 FMI 10, or SID 60 FMI 10 as indicated by Meritor WABCO TOOLBOX™ Software.
- This fault can be attributed to symptoms described as: ABS and “Brake pressure” fault lamps illuminated and an “audible buzzer” activation. Lamps for optional features may also illuminate (ATC or Traction Control and Park Brake Service). Figure 3.

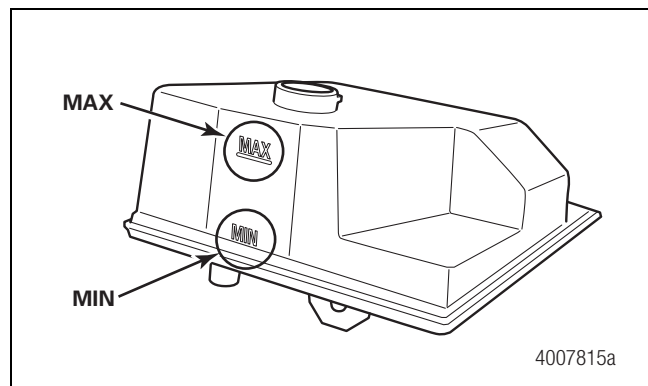
Figure 4

**NOTE:** Take care to ensure the fluid is at the correct level to avoid over-filling the system and to avoid soaking the cap’s filter mesh in brake fluid when the system depletes. According to the filling procedure, the fluid level should be at the “Max” line when the accumulators are depleted. With the system fully charged, the fluid level should be 0.98-inch (25 mm) below the MAX line. Refer to technical bulletin TP-09121 for additional information. Figure 4.
